## **PRODUCT SUPPORT BULLETIN**

### **Title: TR 3900/4500: Elevation System Adjustment**

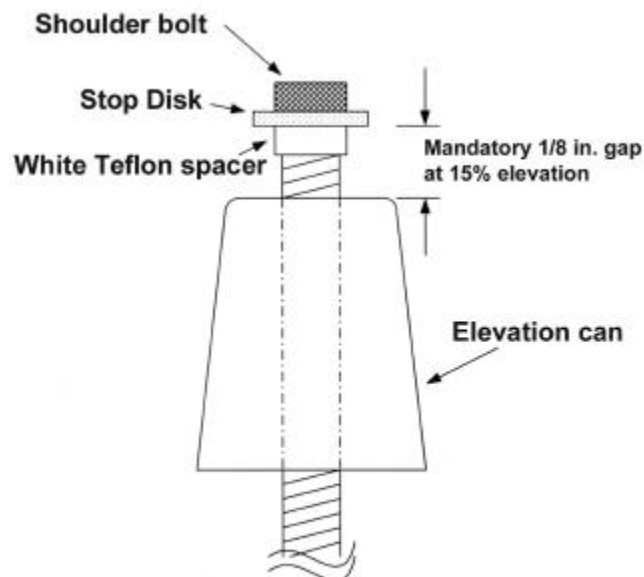
**Cause:** One cause for the EL1/EL STL is when the elevation motor can not reach its intended destination. This happens mostly while the machine is trying to reach 15% elevation.

Required clearance on finished treadmill at 15% incline

1. Elevate the machine to 15% or as close to it as possible if it was not already there. Note: You may get an EL1 while attempting this.
2. Loosen the U-bolts that hold the front handrail to the frame (this is under the motor shroud) and raise the front rail about 1 inch or until the elevation cap is visible.
3. If there is at least a 1/8-inch gap between the elevation cap and elevation can, no adjustment is needed. If there is not a gap, proceed to step 4.
