PRODUCT SUPPORT BULLETIN

Date: January 13, 2003	Bulletin No: 635-0306	Model(s) Affected: Pro Tread Series
Title Pro Tread Series: NO SENSOR Code and the IR Comp Adjustment

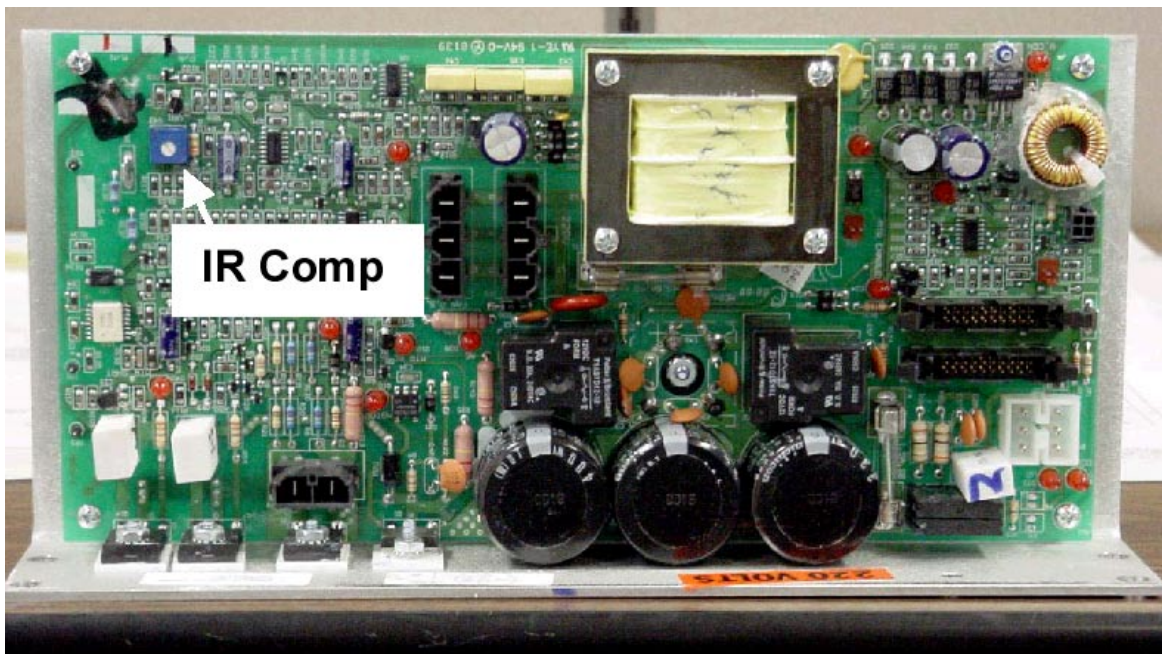
NO SENSOR appears on the display. After engaging the Motor Test Mode and increasing the PWM number, there is no response from the running belt (no motor movement).

Use a small flat screwdriver and rotate the IR COMP potentiometer clockwise or counter-clockwise until the running belt moves. If the running belt does not move after rotating the IR COMP completely, contact Star Trac Product Support.
