## SERVICE BULLETIN

### Shorted RPM Sensors

Applies to: 10G Stepmill (9-5285 + 9-5295), 10TRx (9-9271 + 9-9274), 8TRx (9-9201 + 9-9204 + 9-9251 + 9-9291 + 9-9294) 8TR (9-9281 + 9-9284), S-TRc (9-3581 + 9-3582)

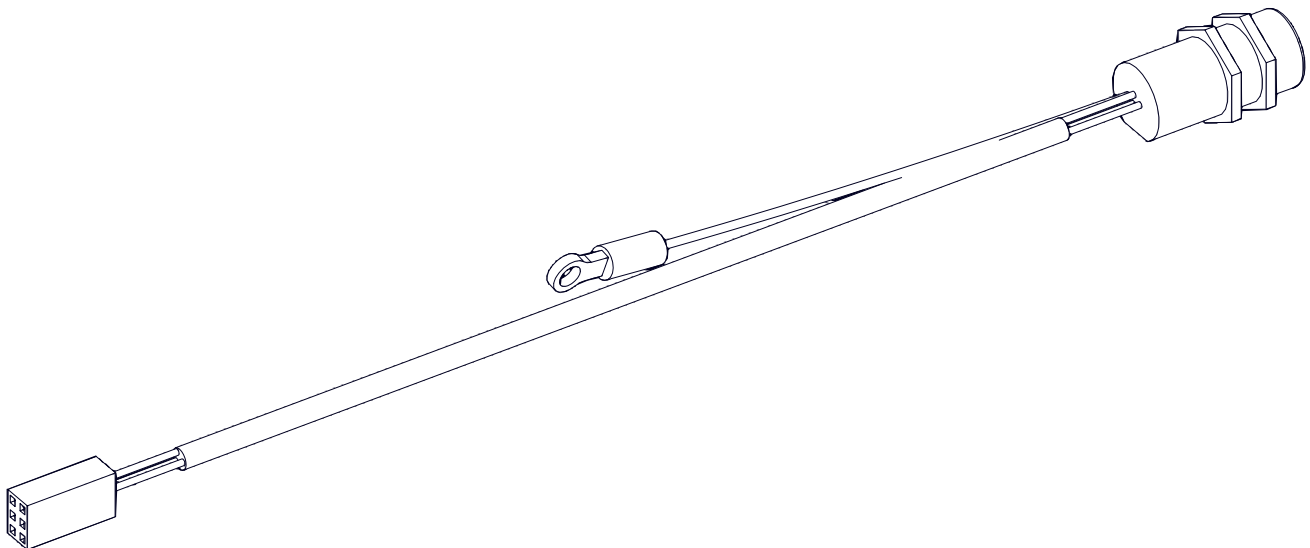
Fig. 1

Recently there have been reports of RPM sensors (560-0069) causing problems on the 10G Stepmill and Star Trac commercial treadmills. Upon inspection, these sensors were found to be shorted.

560-0069 "ASSY, GEAR TOOTH SENSOR, 6PIN"

Solution: Should you suspect a shorted RPM sensor on a 10G, **replace the LCB and RPM sensor at the same time**. DO NOT plug the suspect RPM sensor into a new/known good LCB as this will cause the LCB to fail.

Solution: Replace the RPM sensor.
