Seat Latch Not Fitting In Carriage

E- Series Recumbent Bikes

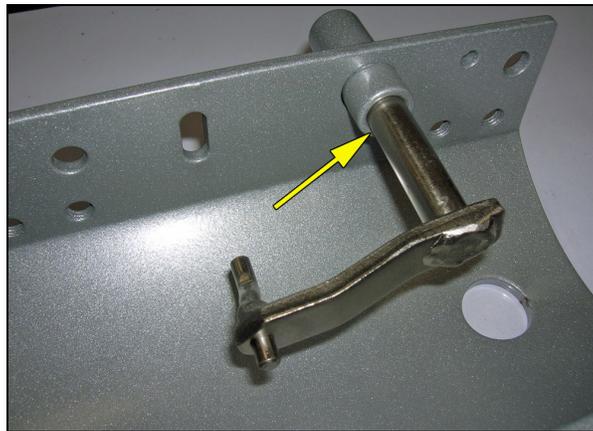
Fig. 1

There have been reports that the E-series recumbent bike seat latch is slightly large and cannot be inserted into the hole of the carriage (Fig. 1).

There is excess paint inside the hole which will not allow the new latch to fit.

Use a file (Fig. 2) to remove some of the paint inside the hole (Fig 3).
