## Trouble Shooting - Excess Lateral UB Arm Movement

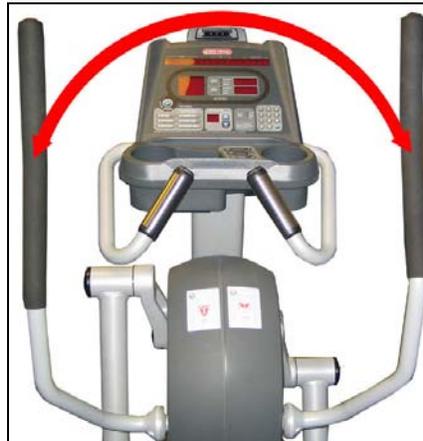
The Upper Body Arms on the Star Trac CrossTrainer should have little to no lateral movement (side to side).

If a CrossTrainer has excessive lateral movement do the following.
