Trouble Shooting - Noises : Pinging

While striding on the Star Trac CrossTrainer, a pinging (metal on metal) noise is heard.

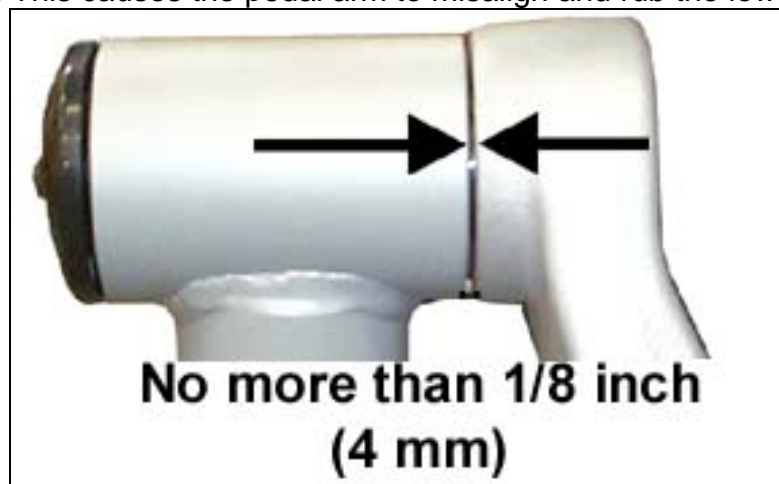
Check the Upper Crank arm/Pin

- The pin has come loose on the upper crank arm.
- Not enough clearance between the lower crank disk and the bolt on the end of the pedal arm.

1. Check the gap between the crank arm and leg assemblies (right and left). There should be no more than 1/8 inch (4 mm) gap.
2. If there is more than 1/8 inch (4 mm) gap, replace the crank arm (721-0109). The pin has come loose and shifted. This causes the pedal arm to misalign and rub the lower crank disk.

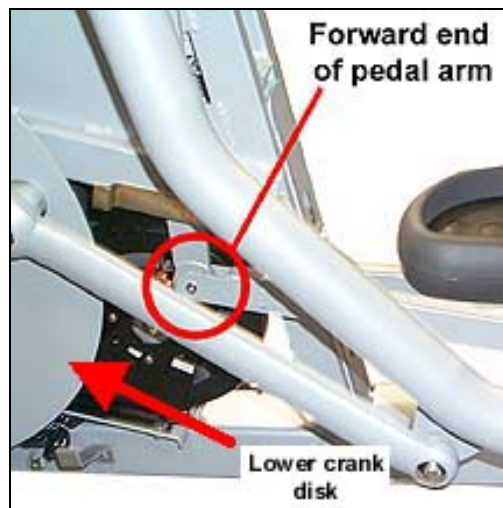
2. Have someone ride the unit and verify where the contact between the pedal arm and the disk is occurring.
3. If the head of the bolt in the forward end of the pedal arm is hitting the disk, you may be able to adjust the position of the bolt by twisting the arm to eliminate the noise.
