<div>MATRIX</div> <div>Service Bulletin</div> <div>Announcing Matrix ClimbMill Improvements</div>		
Effective Date: April 16, 2015	Models Affected: C-3X-F (CS21), C-5x/7x-01-F (CS17/CS22/CS23/CS24)	Bulletin Num.
Prepared by: Eric Chen		NB-1505004

ClimbMill Improvements

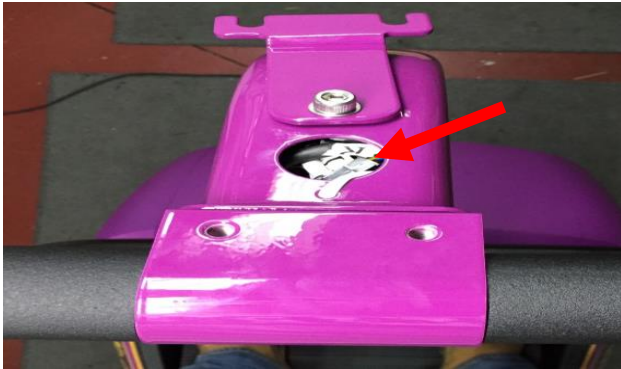
Case 1: Console mast – Modify threading hole shape

Old – Round, small threading hole

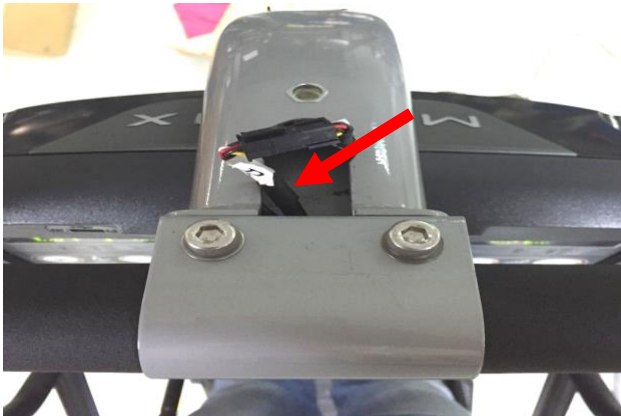
New – Long, larger threading hole

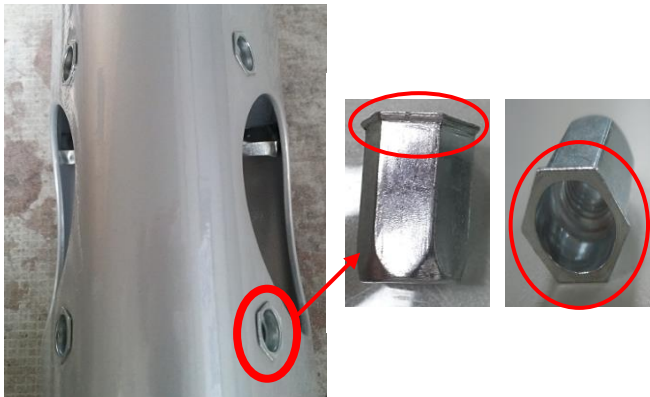
Case 2: Console mast – Modify nut shape for easier assembly

Old – Console mast with a thin hexagonal nut

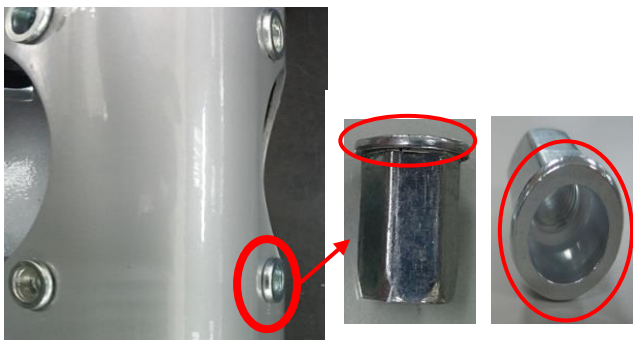
New – Console mast with a thicker hexagonal nut

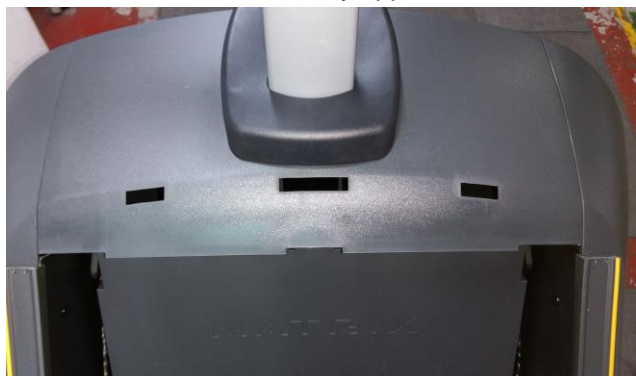
Case 3: Front shield – Modify upper shield to combine with a waterproof anti-sweat plate

Old – See photo

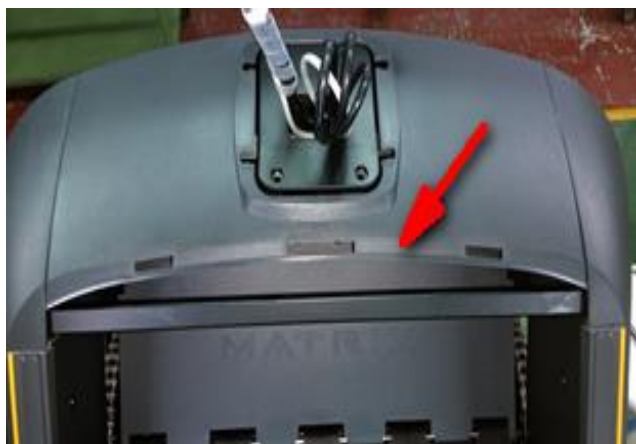
New – Upper shield combined with an anti-sweat plate

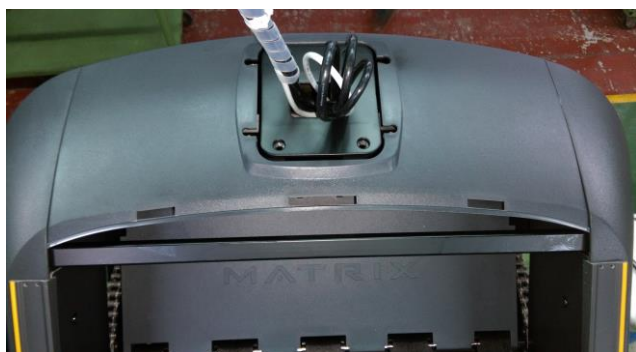
Case 4: Front shield – Add a waterproof anti-sweat plate (soldered on by the factory)

Old – Without the anti-sweat plate

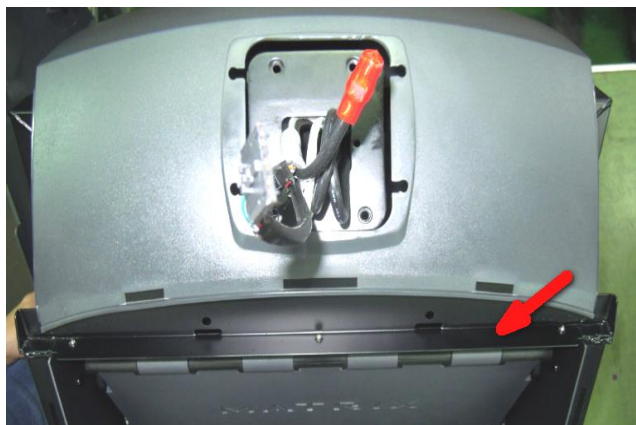
New – With the anti-sweat plate

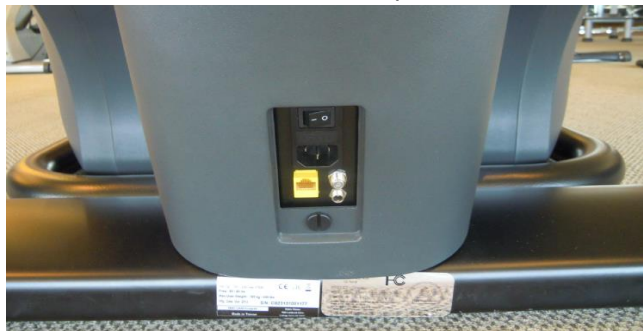
Case 5: Front shield – Add a rustproof drain route/hole on the front cover

Old – Front cover without a drain route and hole

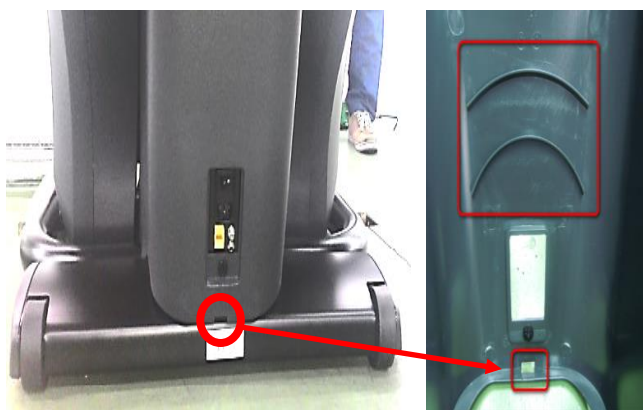
New – Front cover with a drain route and hole

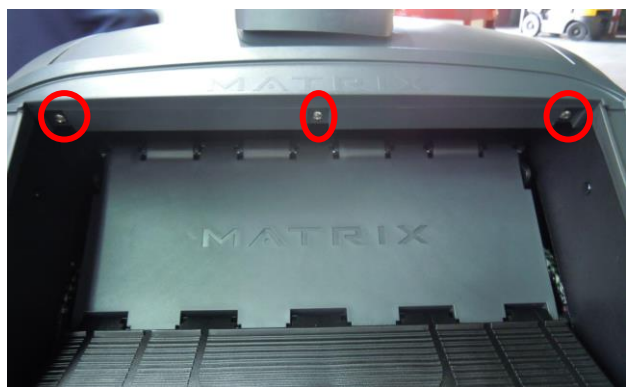
Case 6: Front shield – Matrix cover screws are changed to rustproof stainless steel

Old – Non-stainless steel screw

New – Stainless steel screw

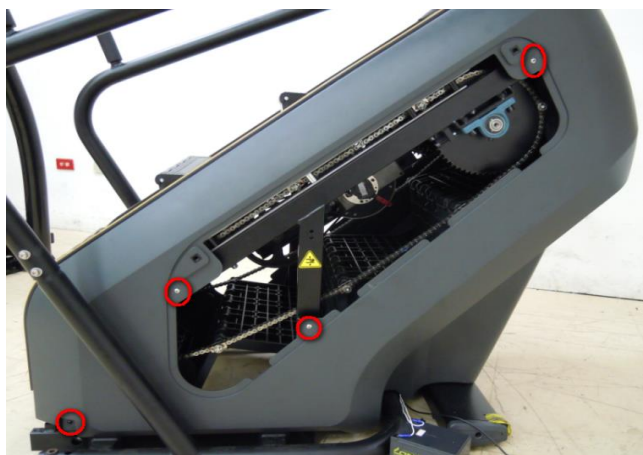
Case 7: Side cover - Screws are changed to rustproof stainless steel

Old – Non-stainless steel screw

New – Stainless steel screw

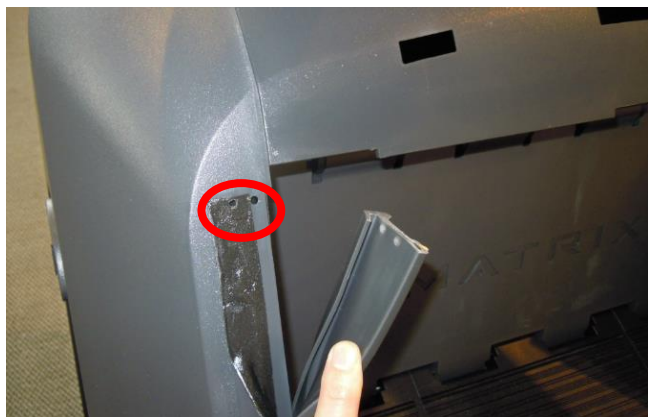
Case 8: Side cover - Location hole on side covers is removed

Old – Side cover with location hole

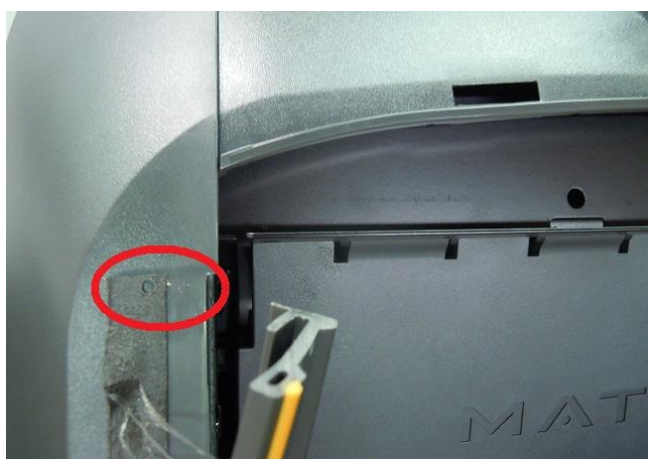
New – Side cover with location hole removed

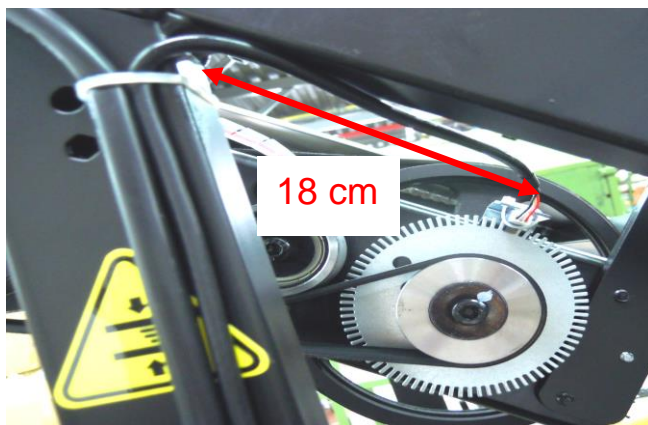
Case 9: Drive set – RPM wire connection loosened

Old – Wire connection too tight

New – Leave 18cm of RPM wire between the cable tie and speed sensor.

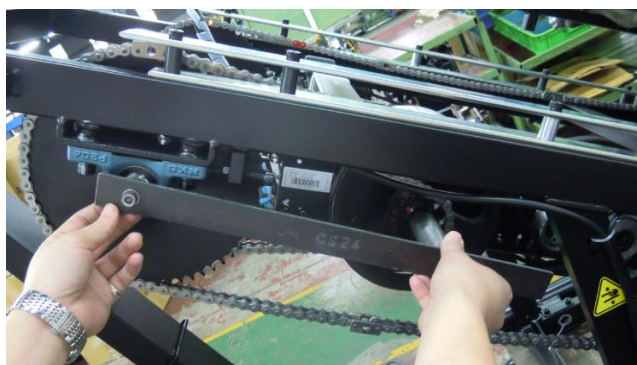
Case 10: Drive set – Drive chain tightness adjusted to resolve noise issue

Old – Use tooling to set up the drive set location

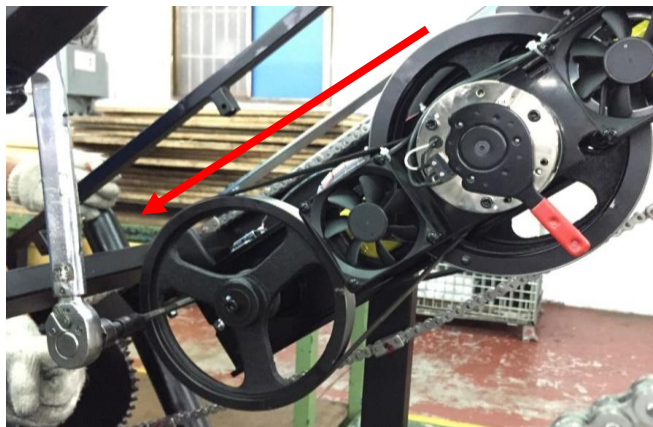
New – Put drive set by natural gravity

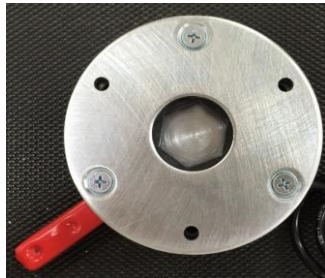
Case 11: Drive set – Brake pad in the center fixed (for spare part only)

Old – Without fixing sleeve

Note: You must remove the fixing sleeve after you assemble DC brake to drive set.

New – With fixing sleeve

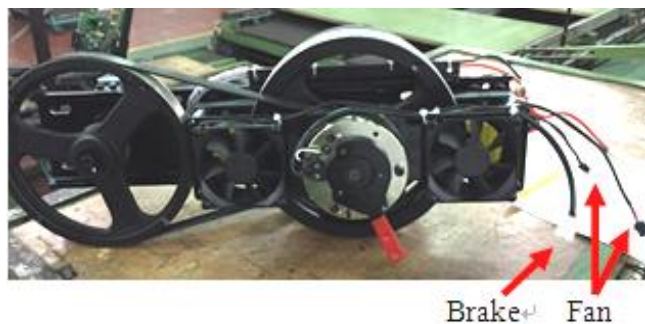
Case 12: Drive set – Fan/DC brake wire location modified for easier repair

Old – Difficult to perform repair

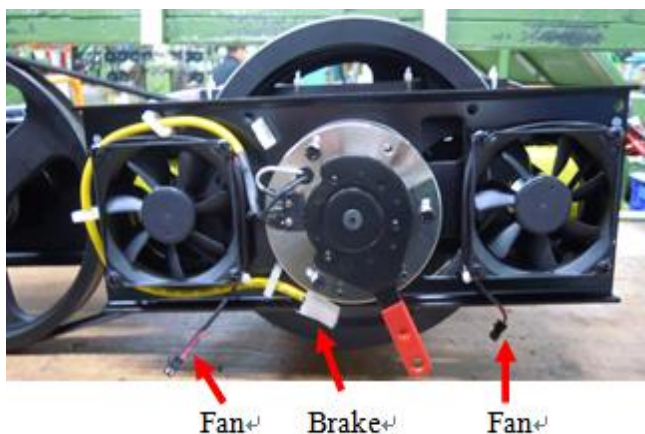
New – Easier to unplug and fix fan/brake wire

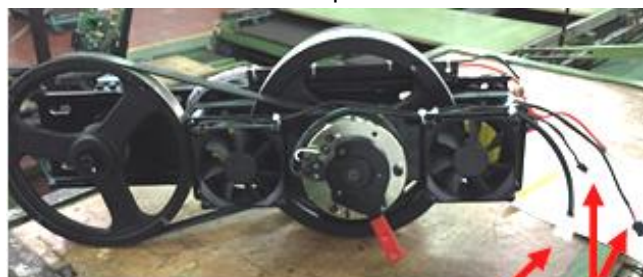
Case 13: Drive set – Brake power cable tube color changed to yellow so it's easy to distinguish

Brake Fan

Old – Black brake power cable

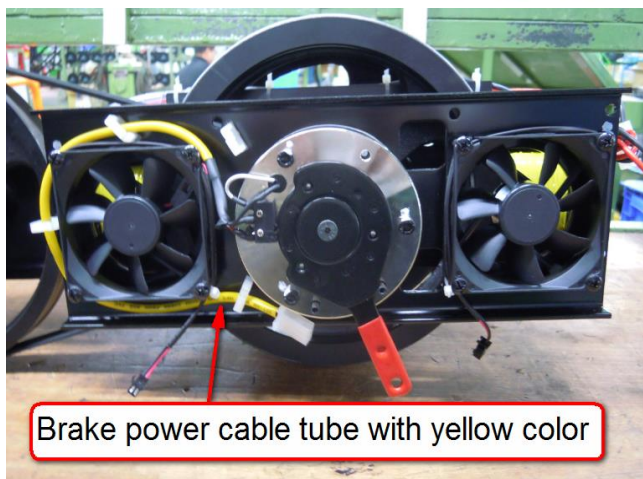
Brake power cable tube with yellow color

New – Yellow brake power cable

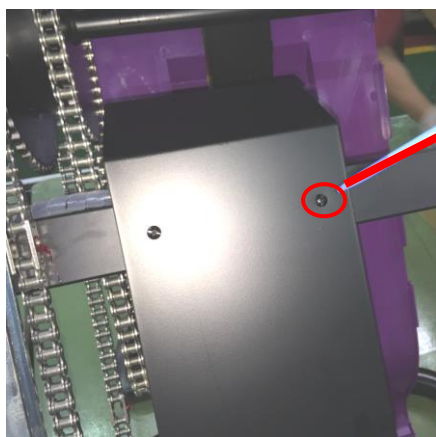
Case 14: Drive set – Fixing plate screw type modified for easier disassembly

Oval crisscross screw

Old – Oval crisscross screw

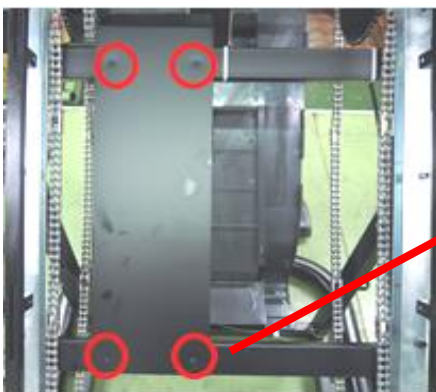
Socket head screw

New – Socket head screw

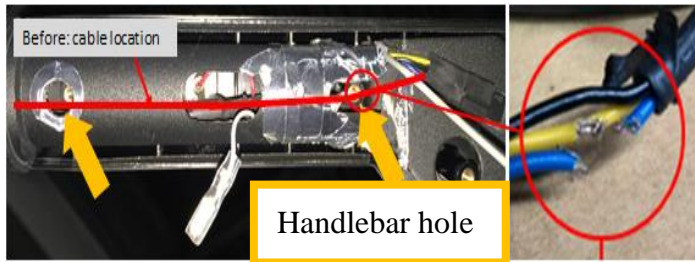
Case 15: Hand grip – Hand pulse wire location changed to prevent wire damage

Old –

- There is no cable tie to keep the hand pulse wire in place.
- Hand pulse wire goes over the handlebar hole. The wire would be damaged when hand grip cover is assembled.

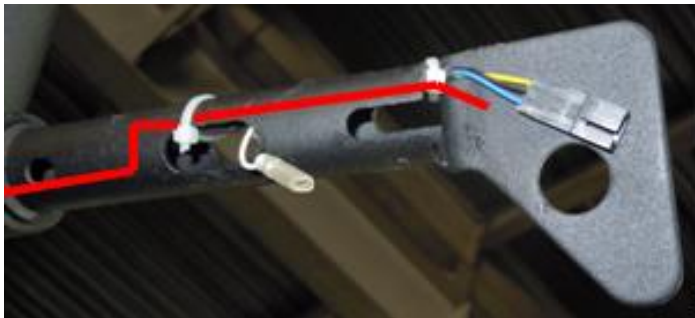
New –

- Add two cable ties to fix the hand pulse wire in place.
- Hand pulse wire doesn't go over the handlebar hole.

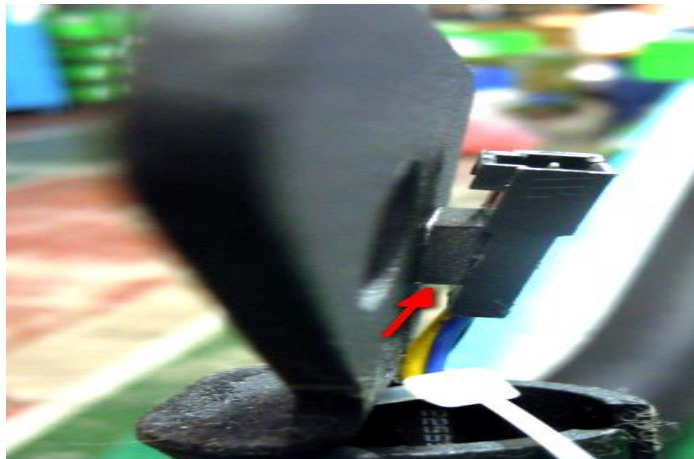
Case 16: Hand pulse wire connector would become loose

Old – Foam tape with 1.5 mm thickness

New – Foam tape with 2.5 mm thickness to prevent wire connector from becoming loose

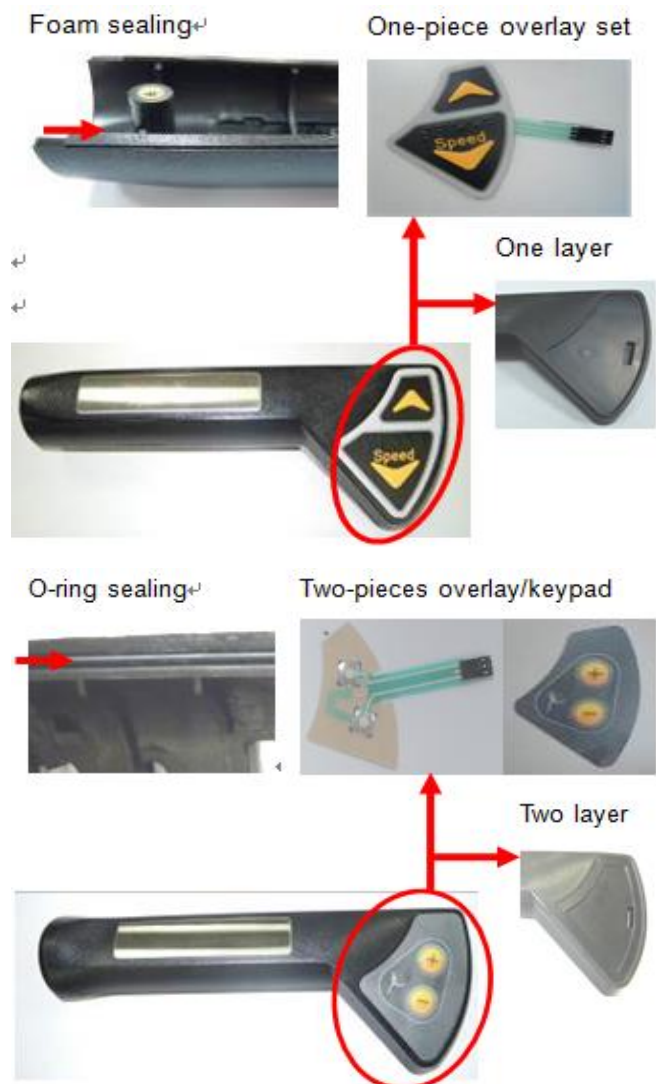
Case 17: Design a brand new hand grip/overlay/keypad (TBD)

Old –

- One-piece overlay set
- Hand grip with foam sealing

New –

- Two-piece-with new overlay/keypad.
- Brand new hand grip with O-ring sealing.

Note: The new and old hand grip/overlay/keypad are not compatible. If the old hand grip set is defective, you must order and replace two new hand grip sets (parts no. #1000359150/1000359164) at the same time.

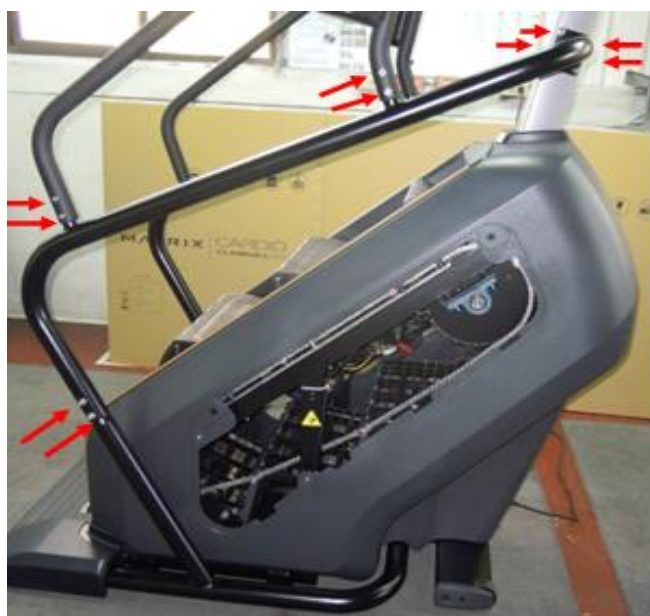
Case 18: Arm rest set – Screws are changed to step screws for easier assembly

Old – Not a step screw

New – Step screw (1000356178 / USD 0.18)

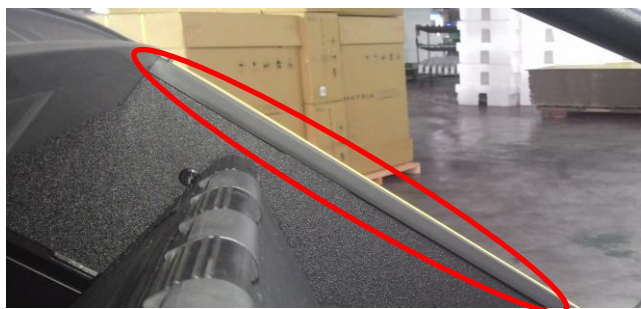
Case 19: Side rail – Modify the side rail width

Old – Narrow side rail

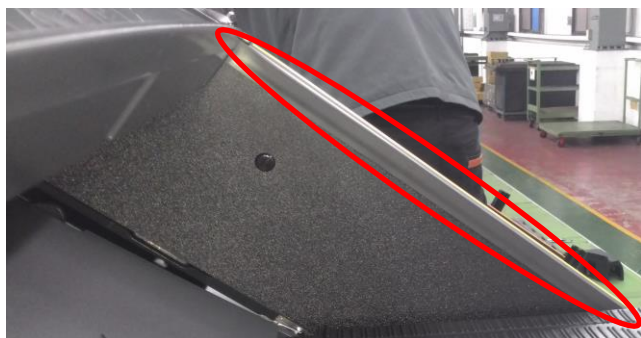
New – Wider side rail

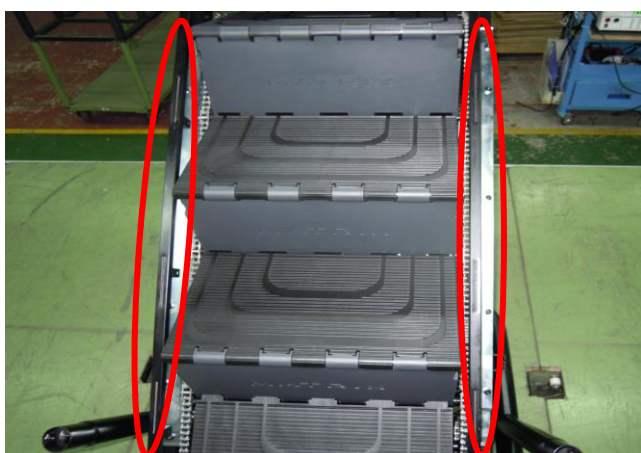
Case 20: Guide rail – Guide rails are galvanized to be rustproof

Old – Guide rail with anti-rust grease

New – Galvanized guide rail

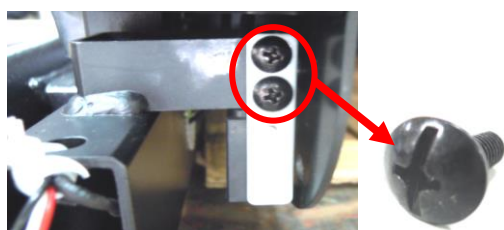
Case 21: Frame IR – Screws are changed to galvanized socket head screws (easier to disassemble and rustproof)

Old – Oval crisscross screw

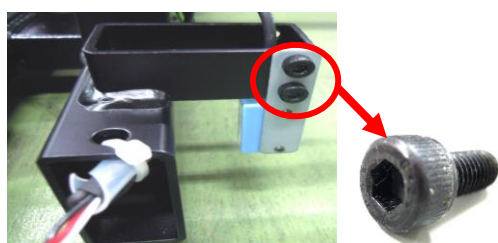
New – Galvanized socket head screw

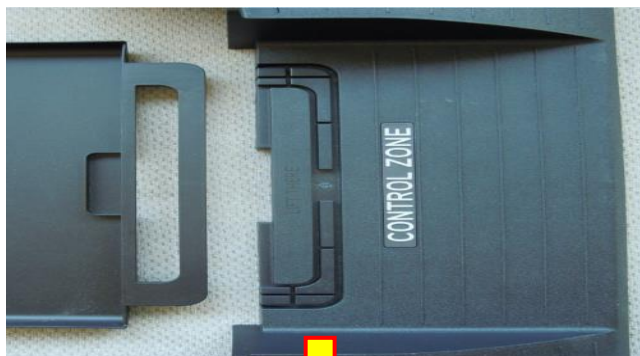
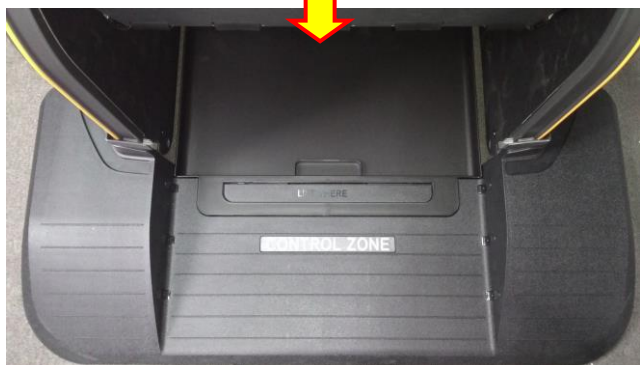
Case 22: Pedal/drip tray – Add a tab to the pedal/drip tray to correct the curve issue

Old – Pedal/drip tray without tab

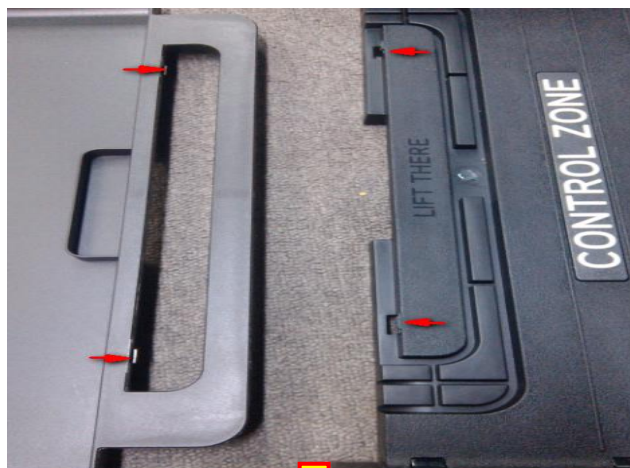
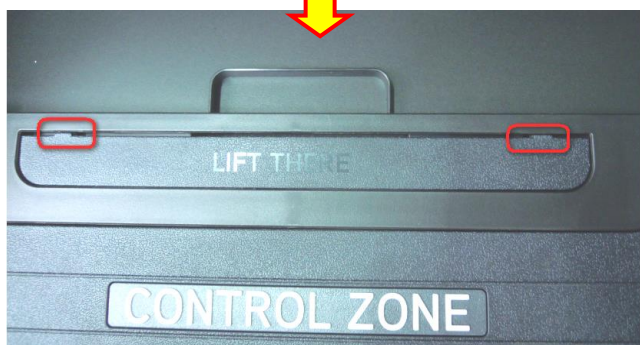
New – Pedal/drip tray with tab

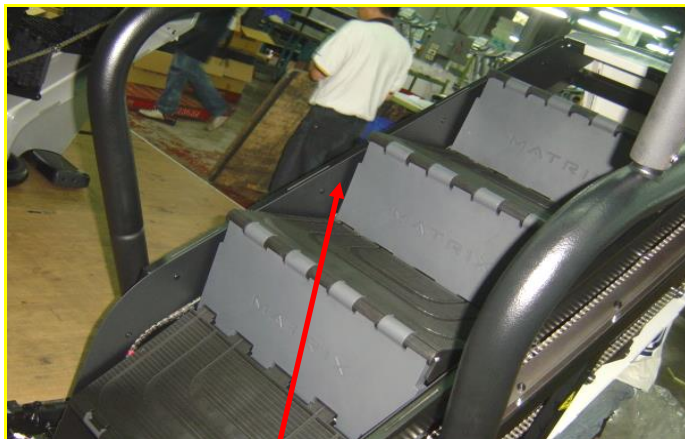
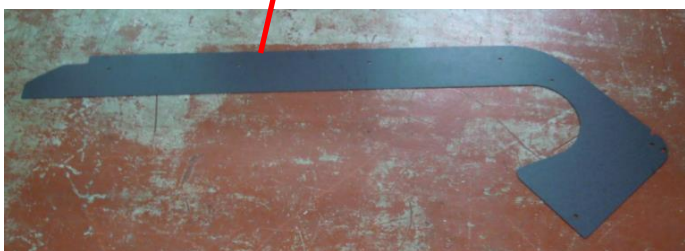
Case 23: Cover plate – Add drain route on the cover plate

Old – Cover plate without a drain route

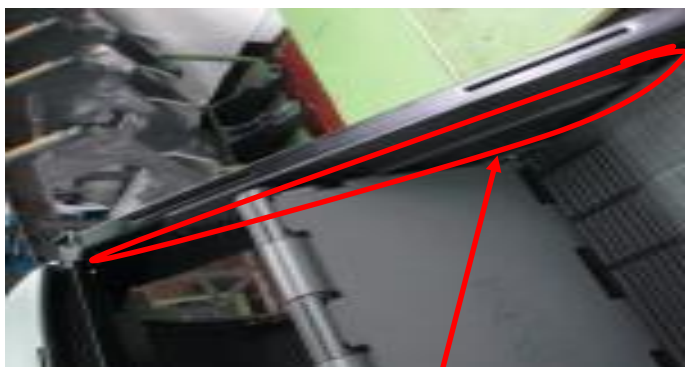
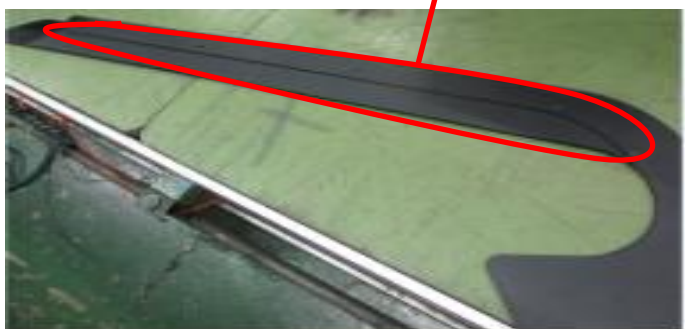
New – Cover plate with a drain route
