Service Bulletin

Cleat Pin Backing Out On Triple Link Pedals

Applies to: Schwinn Triple Link Pedals

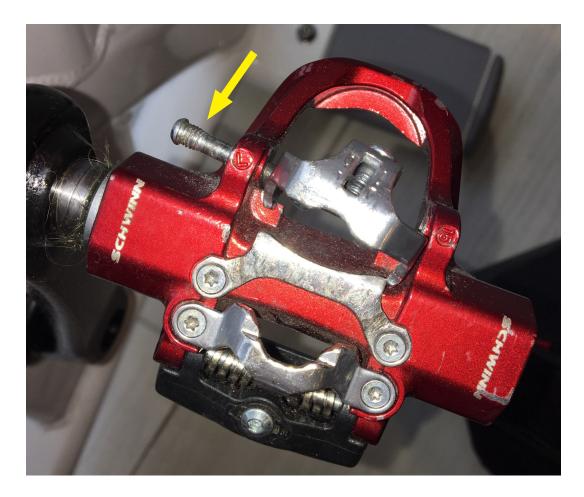
On some Schwinn Triple Link Pedals, an issue has been identified where the pin that holds the pedal cleat to the pedal body can back out, rendering the clip inoperable. Please see image below.

If this occurs, the pedal will need to be replaced:

740-8825: 9/16" Threaded Triple Link Pedal Set.

740-8689: Morse Taper Triple Link Pedal Set w/SPD + LOOK Delta clip. **718-5869**: Morse Taper Triple Link Pedal Set w/SPD + LOOK KEO clip.
