Procedure 7.13 - Replacing a Pillow Block Bearing

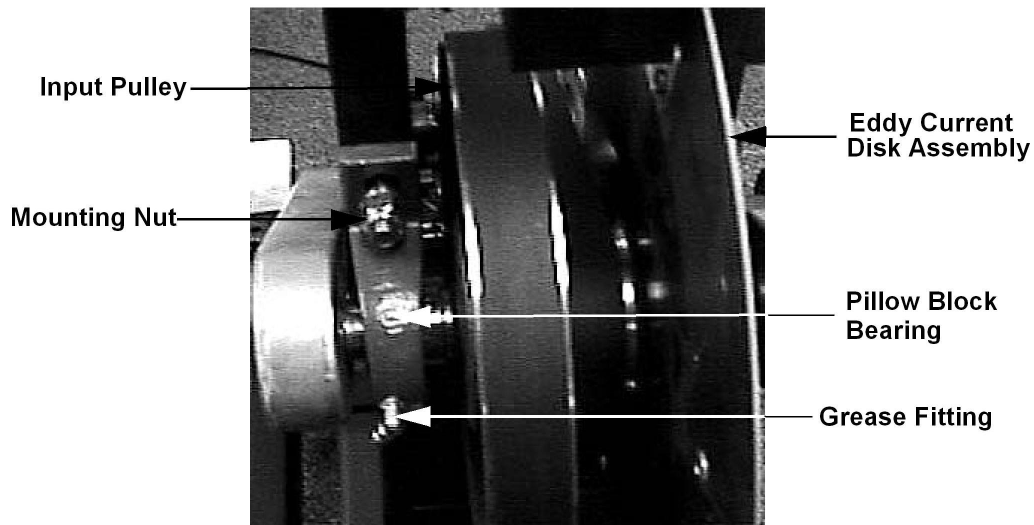
Diagram 7.14 - Pillow Block Bearings

1. Current production of C546s utilize an assembly that consists of the eddy current disk, input pulley assembly and pillow block bearings. The pillow block bearings are permanently attached to the input pulley shaft and can not be removed. If you encounter a situation where a pillow block bearing is damaged and requires replacement, the entire assembly consisting of eddy current disk, input pulley and pillow block bearings must be replaced. See Procedure 7.17 for replacement instructions.
2. The pillow block bearings contains grease fitting. It is recommended that the bearings be periodically checked and greased if necessary.
