Pedal Design Change

SC916 and SC5

This document explains the change that was made to the SC916 and SC5 model pedals.

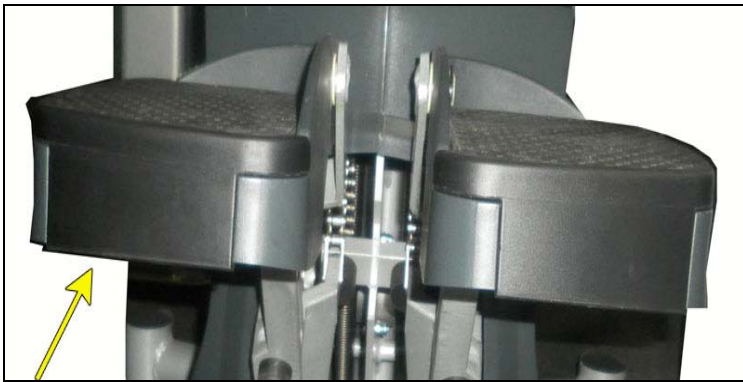
Fig. 1

On the previous pedal design, there have been reports the flaps on the pedals were detaching or tearing from the upper portion of the pedal (Fig. 1 and Fig. 2).

StairMaster has made a design change to eliminate the previous issue. The newly designed part numbers are

- 055-0089, left pedal assembly
- 055-0093, right pedal assembly

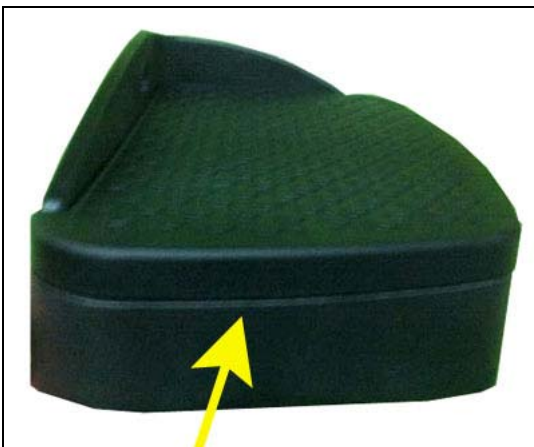
The new design provides a secure pad with no additional rubber on the pedal (Fig. 2). As Fig. 3 and Fig. 4 show, there are no flaps of plastic between the top of the pad to the base of the pad.
