Most Common Error Codes Guide

Embedded Touch Screens

This guide contains troubleshooting for the most common error codes that may occur on an embedded touch screen.

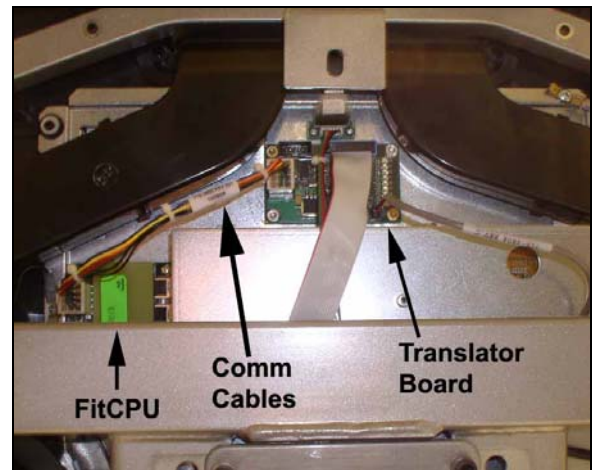
Fig. 1

1. Turn the treadmill off by the on/off switch.
2. Ensure the communication cable between the Translator Board and FitCPU are firmly connected.
3. Turn the treadmill back on. If the Error Code 6 continues to appear test communication cable.

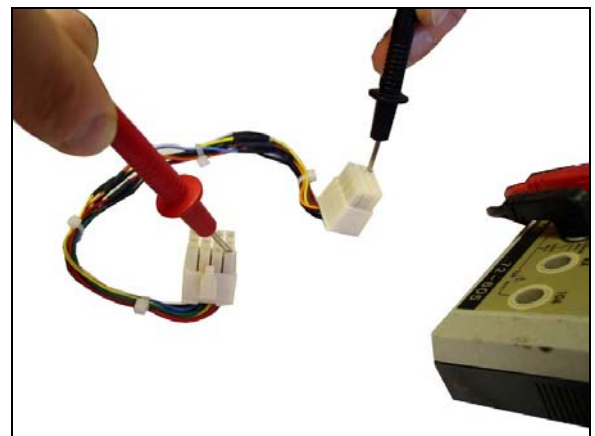
Fig. 2

1. Using a multi-meter, verify that there is continuity between each wire on the communication cable. Check continuity between all wires.
2. If there is no continuity between any of the wires, replace the communication cable. If the communication cables test good, replace the Translator Board.

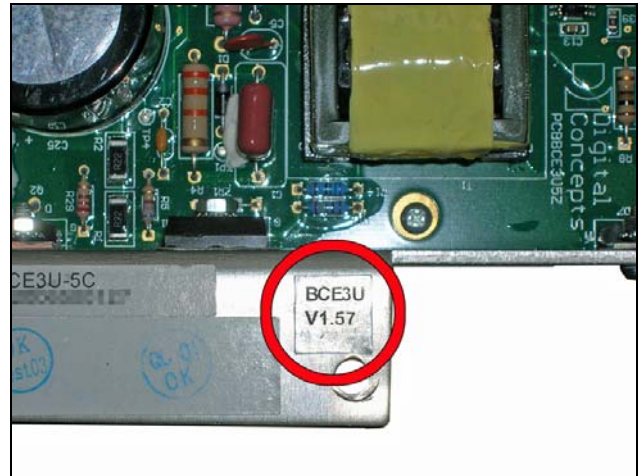
Fig. 3

1. Remove the LCB from the unit.
2. There is a label on each LCB that identifies what version software it contains.
3. The software must be at least version 1.57 or higher. If the software is before 1.57, replace the LCB.

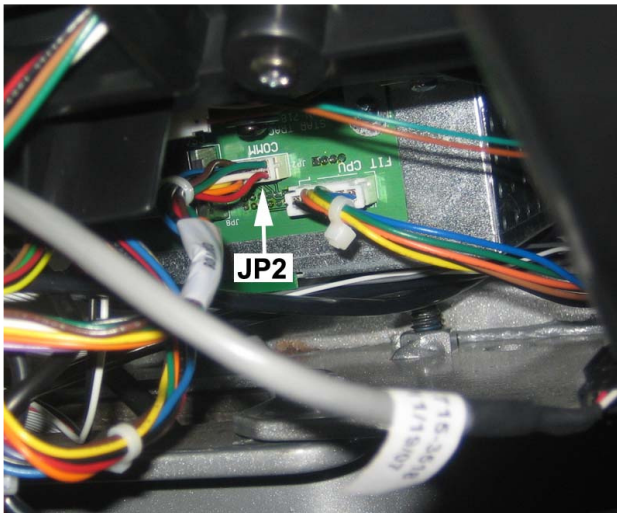
Fig. 1

1. Turn the unit off.
2. Ensure the communication cable (715-3772) between the Display and CCB are firmly connected.
 - a. COMM (JP2) connector on the bottom of the display.
 - b. Power cable is plugged into the JP6 on the CCB.
 - c. COMM cable is plugged into JP4 on the CCB.
3. Turn the unit back on. If the Error Code 14 continues to appear, test the communication cable.

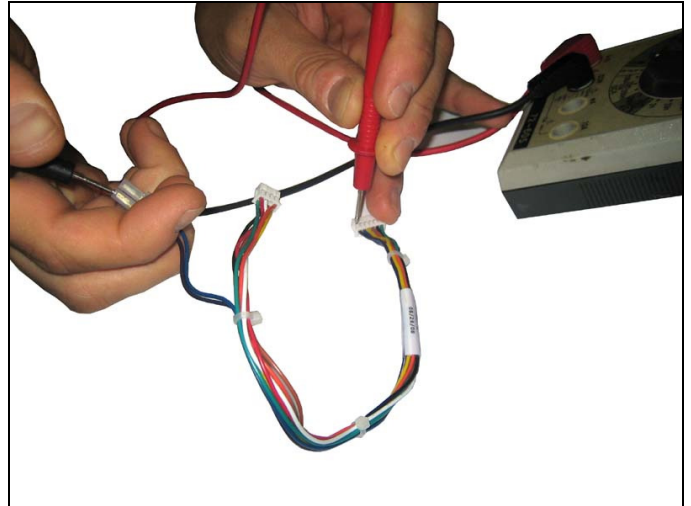
Fig. 3

1. Using a multi-meter, verify that there is continuity between each wire on the communication cable (715-3772). Check continuity between all wires.
2. If there is no continuity between any of the wires, replace the communication cable. If the communication cables test good, replace the CCB.

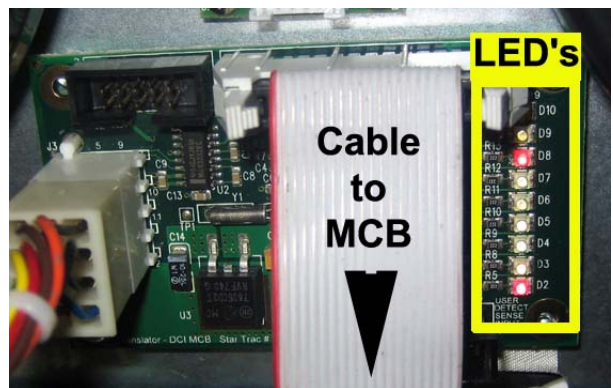
Fig. 1

1. Check the Translator Board (Fig. 1). Verify that some of the LED's on the board are lit.
 - a. If all LED's are off, ensure the ribbon cable is firmly connected at the Translator Board (Fig. 1) and at the MCB (Fig. 2). Check the ribbon cable for pinches or tears. Replace if any are found.
 - b. If some of the LED's are on, go to step 2.

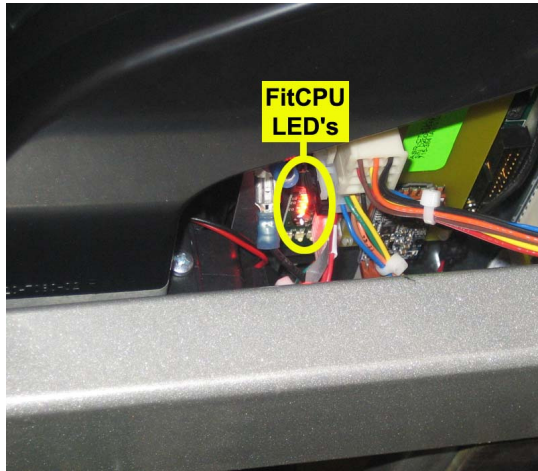
Fig. 3

2. Check the FitCPU. Verify that some of the LED's on the board are lit (Fig. 3).
 - a. If all LED's are off, ensure the comm. cable (715-3800) between the Translator Board and FitCPU is firmly connected (Fig. 4). If FitCPU LED's do not light up, replace comm. cable (715-3800).
 - b. If some of the LED's are on, go to step 3.

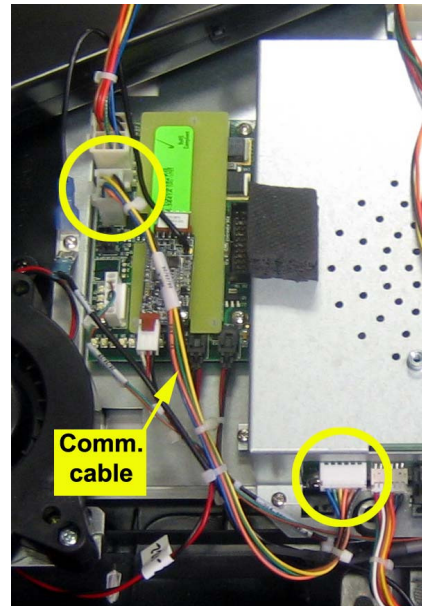
3. Check the display comm. cable (715-3783) connections between the FitCPU (J3) and the Embedded Screen (JP6).
 - a. Disconnect and reconnect to ensure there is a firm connection. *Note: The picture of Fig. 5 is of a screen which is not mounted on a treadmill.*
4. Recycle power again. If the Error Code: 21 continues to appear, replace comm. cable (715-3783).

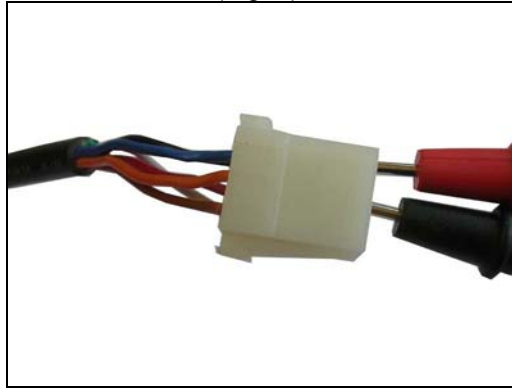
Fig. 4

3. Unplug the elevation motor from the Motor Control Board (MCB). Set the multi-meter to measure ohms. Insert the multi-meter leads: one in the orange wire, one in the blue wire (Fig. 4).

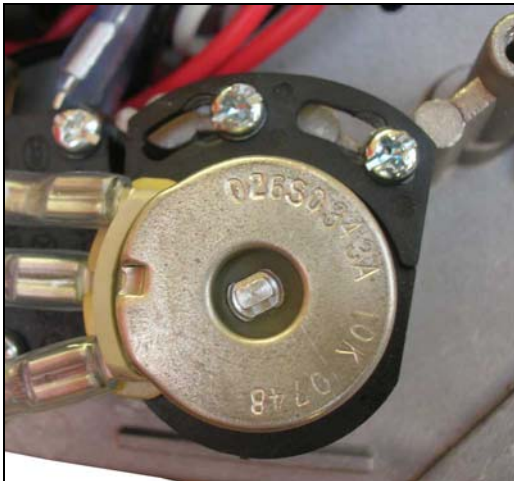
Fig 5

- If the unit is at max elevation, turn the pot counter-clockwise until the screws are completely to the right side of the pot slots (Fig. 5). Tighten the screws.
- If the unit is stuck at 0% elevation, turn the pot clockwise until the screw are completely to the left side of the pot slots (Fig. 6). Tighten the screws.

- If the unit is at the max elevation, the value must be between 500-600 ohms.
- If the unit is at 0%, the value must be between 9.4 – 9.5 k ohms.

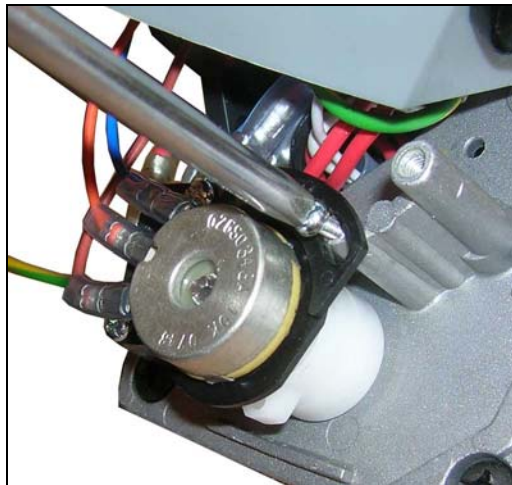
Fig. 9

7. Put the pot back in the motor. Be careful to not twist it. Once the pot is in place, verify that the ohm value is still in the desired range. Install the two screws and tighten the pot in place (Fig. 9).

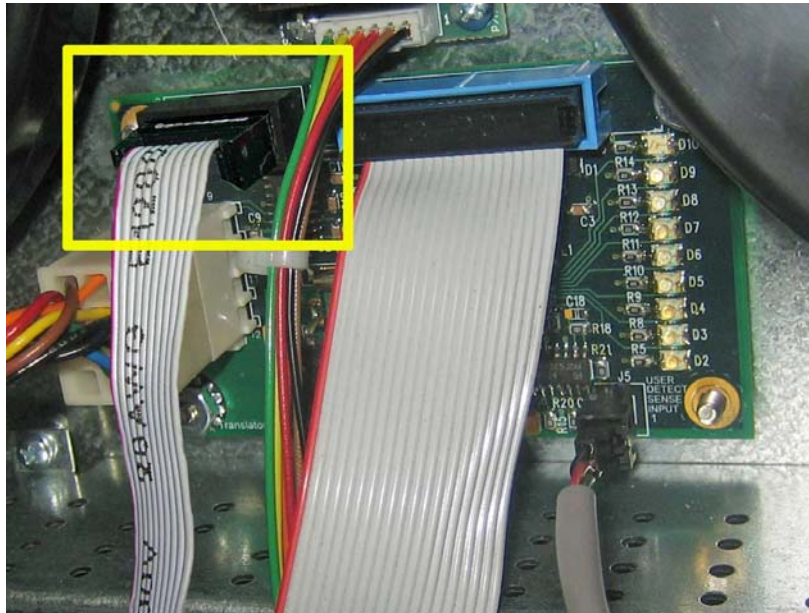
Fig. 10

8. Turn the treadmill on if the Error Code 38 does not appear, turn the treadmill on and go to step 9. If the Error Code 38 continues, use the FISP Uploader to reinstall the translator board software (Fig. 10)

Note: Ensure you are installing the proper version of software for that model (see Service Bulletin: 637-1343). Installing the wrong version will cause the speed calculation to be incorrect.

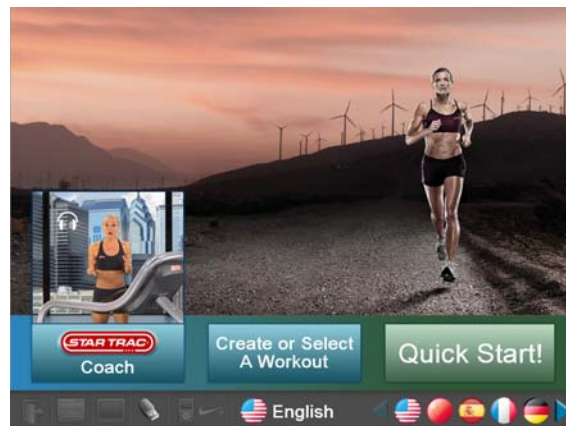
Fig. 1

1. Reboot the machine to clear the EC 42. Once the first splash screen is shown (Fig.1), press the following three keys: channel '+', volume '+' and '3'.

Note: There is 4 second window to enter the “Service Menu” once the first splash screen has been displayed before it displays EC 42 again.

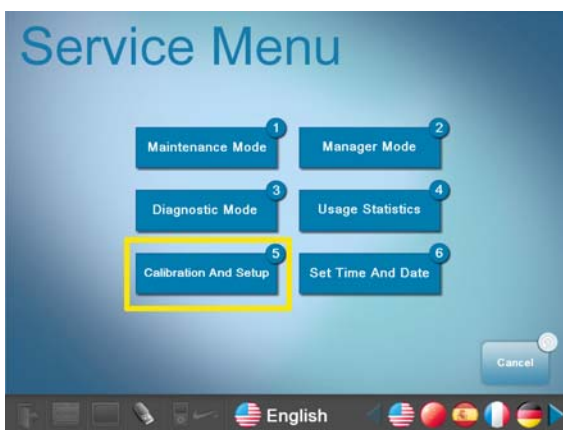
Fig. 2

2. Once in the “Service Menu” press the ‘Calibration and Setup’ (Fig.2). The display will ask for a code which is ‘2 1 8’, then press ‘OK’ on the screen (Fig. 3). Once in “Calibration and Setup”, press ‘Incline Calibration’ (Fig. 4)

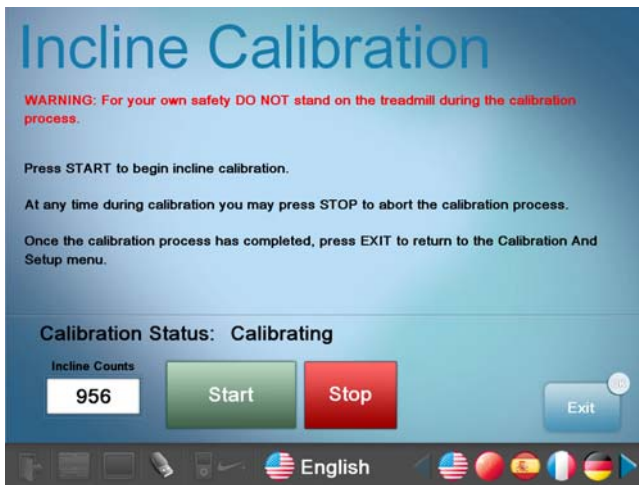
Fig. 5

- Press the 'Start' button to run the elevation calibration program (Fig. 5). Numbers will show on the "Incline Counts". The numbers will decrease while the unit elevates. When done, the Elevation Status will read "Calibration Completed" (Fig. 6).

Note: If the unit stops at the max elevation but "Calibration Completed" does not show, press 'Stop' and then restart the calibration. When the calibration is done, the elevation will not come down until you exit the "Service Menu".
