<b>MATRIX</b>	Service Bulletin: Upgraded handlebar foam for the Matrix elliptical	
	Prepared by: Eric Chen	Date Prepared: 2/4/2015

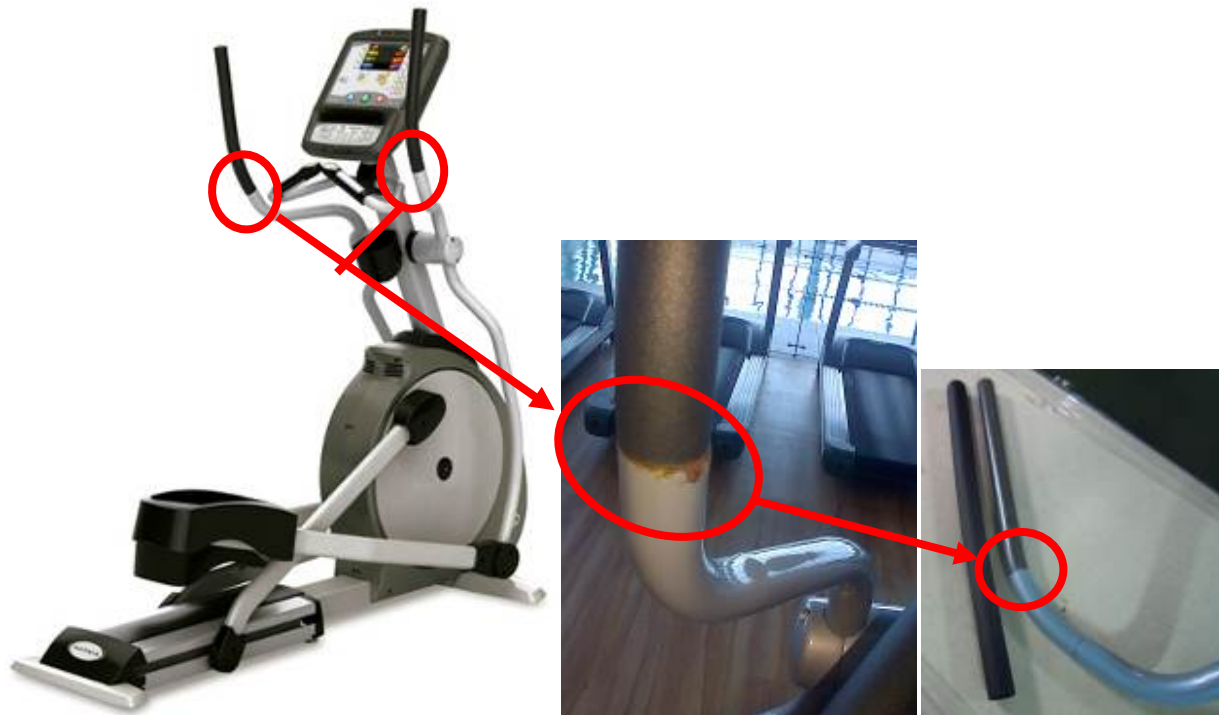
**Figure A**

Matrix has released upgraded handlebar foam for ellipticals that develop rust:

Rust develops because sweat accumulates and infiltrates into the handlebar (Figure A).

1. JHT has changed the handlebar foam by increasing the length to 590mm and diameter to 32mm. This prevents sweat infiltration.
2. The new foam is only used for field service.
3. The new foam is part number **1000359769**. The specifications are  $\Phi 32 \times 3 \times 590$ L (Figure B).
