## Alternator / Resistance Testing

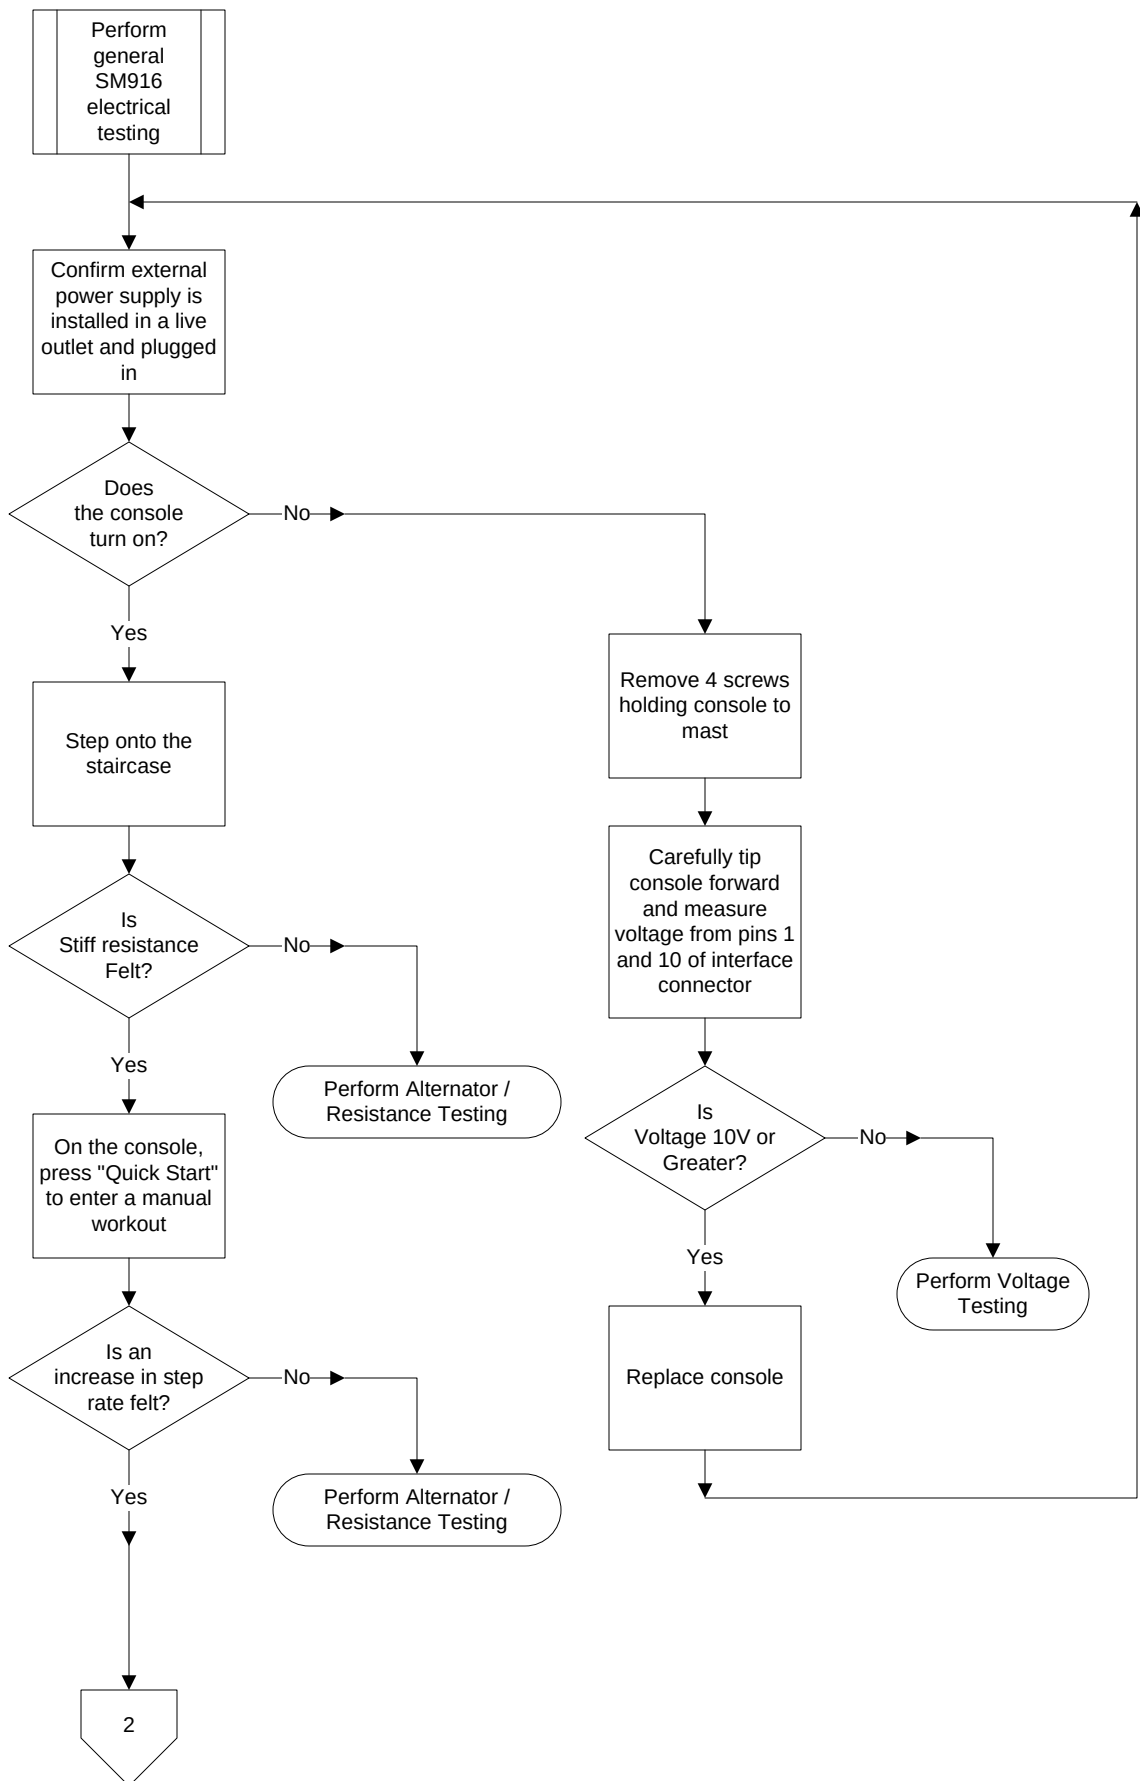
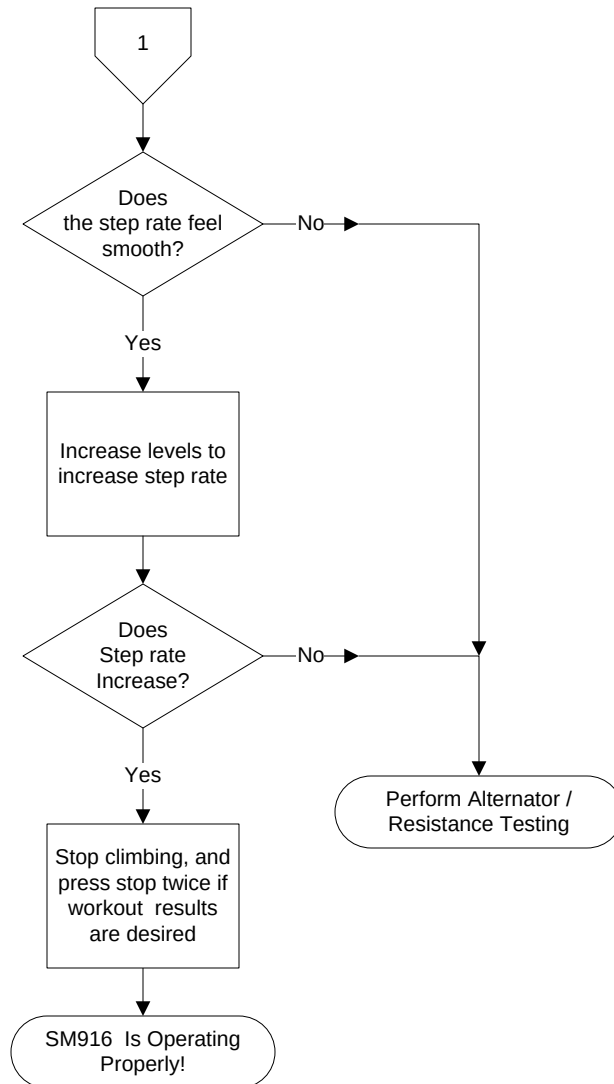
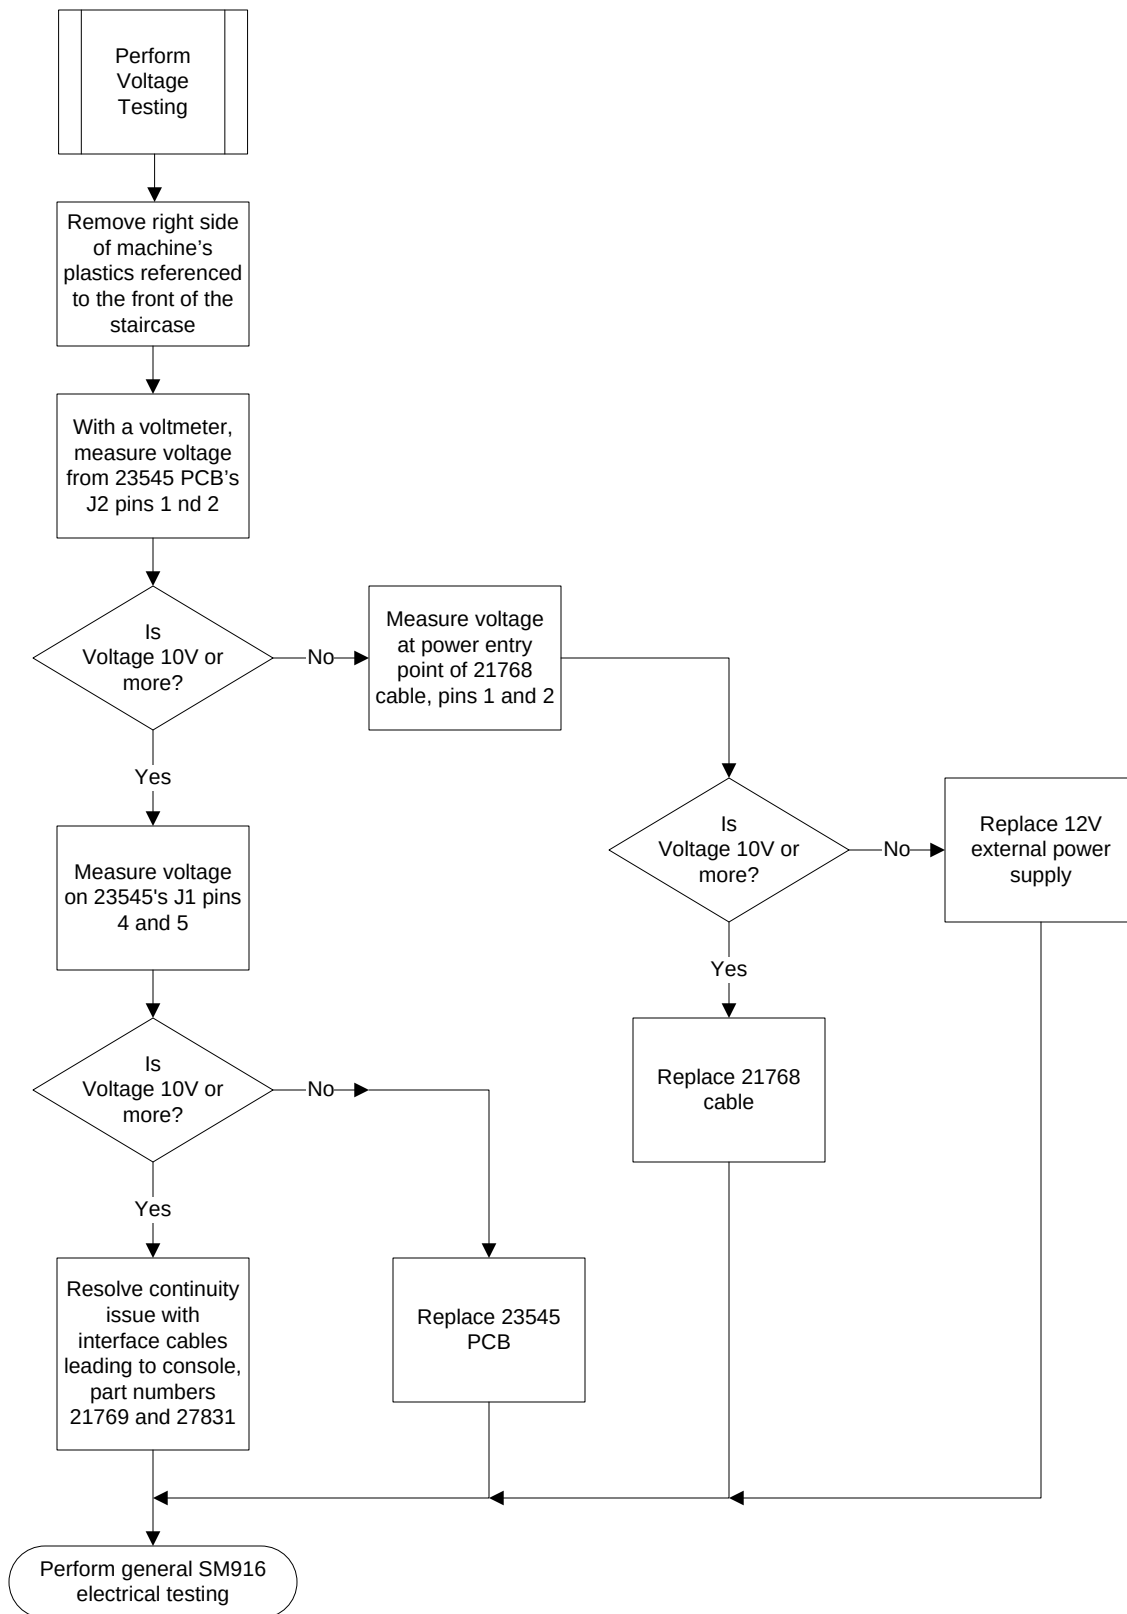
The colored connections to the alternator are as follows:

White-B+, Alternator output voltage

Brown-Field, Alternator Control Current

Black-Ground, Alternator return

Blue-Tachometer, velocity signal back to console

If no resistance is felt, regardless of whether the console is powered, remove the plastic shroud on the right side (with respect to the staircase entry). The 23545 PCB should be visible, along with the load resistor, and alternator. Prior to proceeding with tests below, perform continuity checks on the alternator connections, load resistor connections, and confirm these connections are secure into the 23545 PCB. Confirm the load resistor measures .5ohm.

Power entry is at the bottom of the unit. The 12V 2.5A supply enters via cable part number 21768, and enters into the 23545 PCB via J2. LED2 indicates power is present, but 12V should still be confirmed with a volt meter. Power and control interface to the console is provided at location J1. The cable to the console is made up of two sections for assembly, part numbers 21769 and 27831. 12V is provided up to the console at J1 pin 4, and GND pin 5.

In addition to alternator field current, the console controls the loading of the alternator's B+ with the .5ohm resistor which is switched by the 23545's relay. When the console detects a user has stepped on the staircase, it immediately applies full field current, and turns on the power relay to load B+ with .5ohm. LED1 is an indicator the console is attempting to close the relay, but this should be confirmed with a VOM.

If no resistance is felt, confirm 10V to 12V is being applied to the alternator's field. This should always be present once a user is detected, and before a workout has begun. Confirm the additional load is being switched also, which is controlled by a low voltage on J1 pin 1. The operation of the power relay can be confirmed by unplugging the unit, and removing the console connection at J1. Install external power again, and an ohmmeter should show continuity from B+ to field on the 23545's terminal strip. With a test jumper, connect J1 pin 1 to J1 pin 5, and the ohmmeter should now show continuity from the terminal strip's B+ to RES. If this test passes with no resistance felt, and full field current has been confirmed, replace the alternator. If the above test fails, replace the 23545 PCB. If no field current is detected, or LED1 does not light when a user steps on the staircase, check the interface cable continuity to the console. If this checks, replace the console.
