Poor Battery Life

SC5

An investigation of abnormal battery drain reports has led to a change in the electrical system used on the SC5.

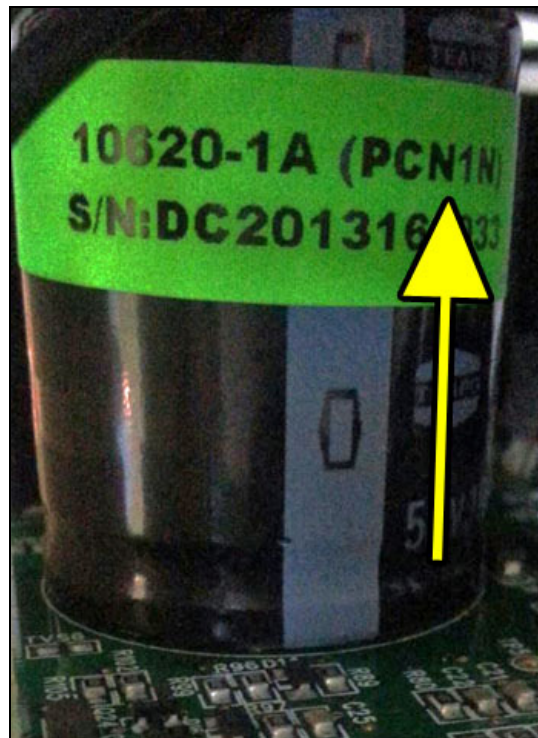
Fig. 5

NOTE: To determine the version of the LCB, locate the green sticker on the LCB (Fig. 5).
The old version of the LCB is labeled “**PCK1N**”. The new version of LCB is labeled “**PCN1N**”.
