## **Procedure 6.2 - Troubleshooting the Keypad and Upper PCA**

## C546 Navy Elliptical Fitness Crosstrainer

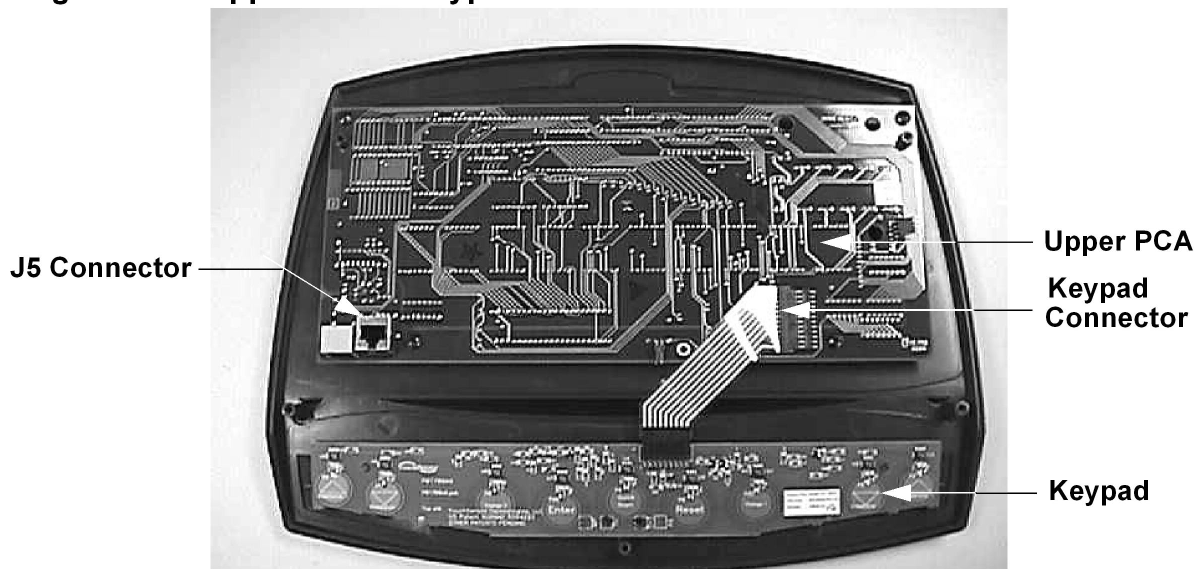
**Diagram 6.3 - Upper PCA & Keypad**

1. Attach the anti-static wrist strap to your arm, then connect the ground lead of the wrist strap to the units frame.
2. If the EFX powers up and functions normally until a particular key(s) is pressed, skip to step 12.
3. If an Errorpr 5 ìkey depressedî message is immediately displayed when the EFX is powered up, continue with the next step.
4. This condition may be caused by either the keypad or upper PCA.
5. Remove the five screws that fastens the display housing front panel to the display housing backing plate. These screws are located on the rear of the display housing backing plate.
6. Lift the display housing front panel off of the display housing backing plate. Remove the keypad connector from the upper PCA. See Diagram 6.3.

7. Set the on/off switch in the **on** position.
8. If an **Error 5 key depressed** message is immediately displayed when the EFX is powered up, replace the upper PCA.

9. If a **key depressed** message is not displayed when the EFX is powered up, replace the display housing front panel. The display housing front panel is equipped with the keypad.

14. If one or more keys do not function correctly, either the keypad (display housing) or upper PCA could be defective. Replace the display and repeat step 12. If the display housing did not correct the problem, re-install the original display housing and replace the upper PCA.
