## Service Bulletin

### Cleat Pin Backing Out On Triple Link Pedals

*Applies to: Schwinn Triple Link Pedals*

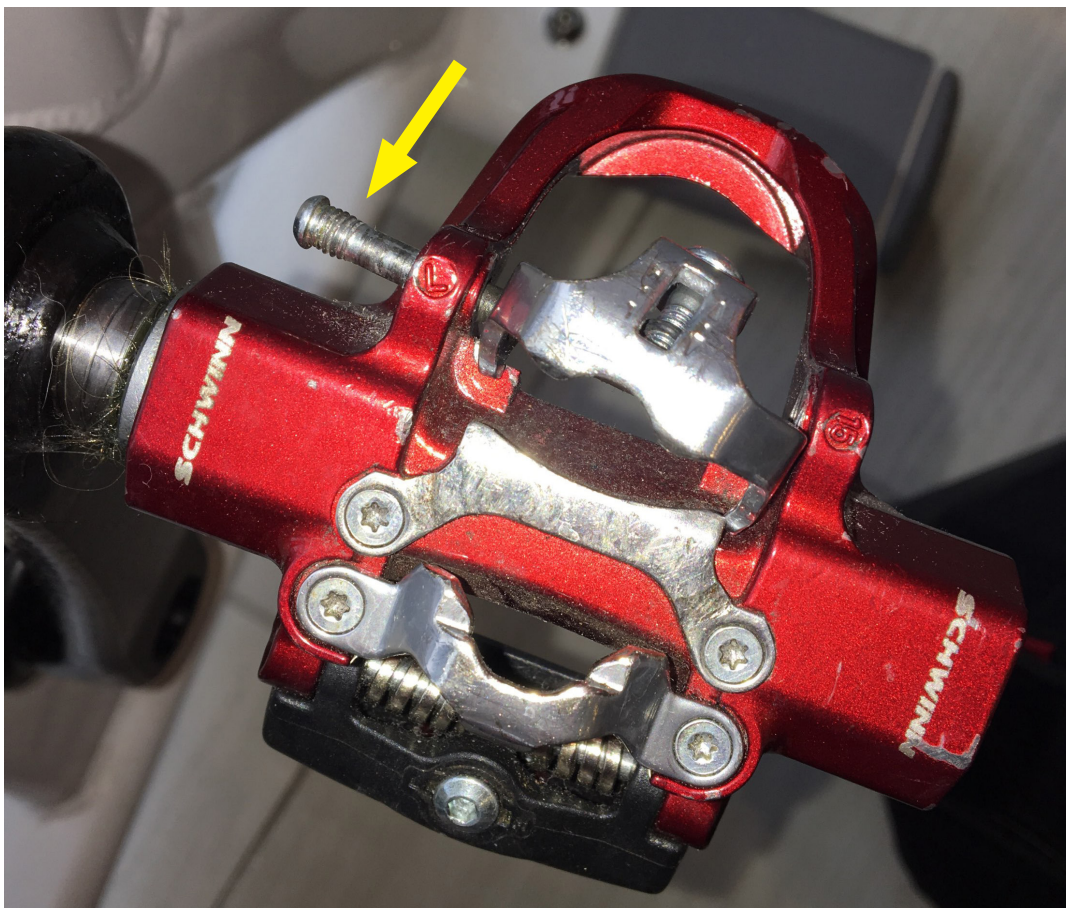
On some Schwinn Triple Link Pedals, an issue has been identified where the pin that holds the pedal cleat to the pedal body can back out, rendering the clip inoperable. Please see image below.

If this occurs, the pedal will need to be replaced:

**740-8825:** 9/16" Threaded Triple Link Pedal Set.

**740-8689:** Morse Taper Triple Link Pedal Set w/SPD + LOOK Delta clip.

**718-5869:** Morse Taper Triple Link Pedal Set w/SPD + LOOK KEO clip.
