## Poor Battery Life

### SC5

An investigation of abnormal battery drain reports has led to a change in the electrical system used on the SC5.

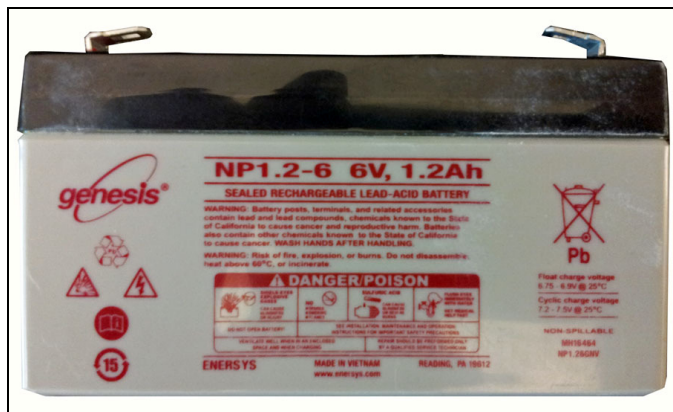
Fig. 1

- Old Battery (Fig.1) **PN: 14123**
- New Battery (Fig.2) **PN: 055-0209**

Should you have a drained battery on an SC5 before serial number **155005DAY12340116**, you must replace the LCB and battery together.

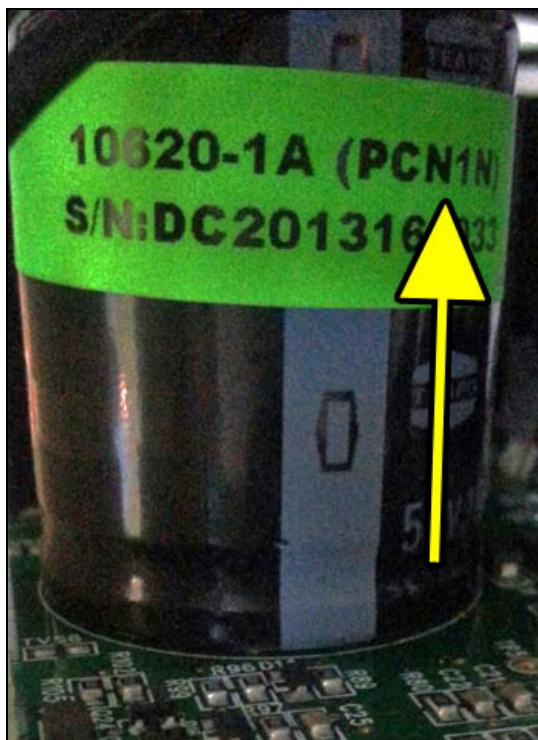
Fig. 5

**NOTE:** To determine the version of the LCB, locate the green sticker on the LCB (Fig. 5).  
The old version of the LCB is labeled “**PCK1N**”. The new version of LCB is labeled “**PCN1N**”.
