Replacing the Drive Motor

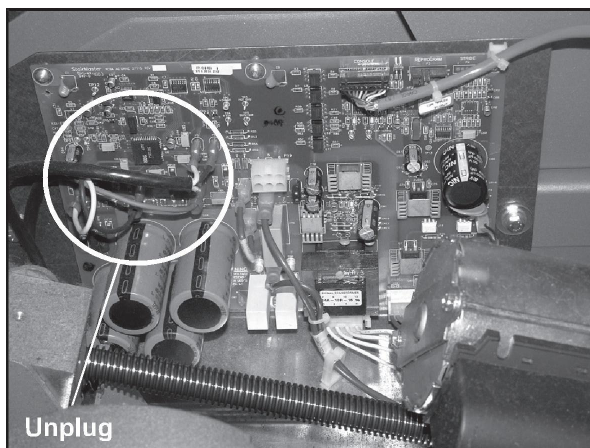
- 2.1 Disconnect P5, P6, P7, P8, and P9 from the VSD board. (See appropriate wiring schematic on pages 46-48 for the location of where the plugs connect to the VSD board.)
